Property Inspection Report

Report Number: 07-25-2019

345 Sample Street
Pinehurst, North Carolina 28374

Date of Inspection: Thursday, July 25, 2019

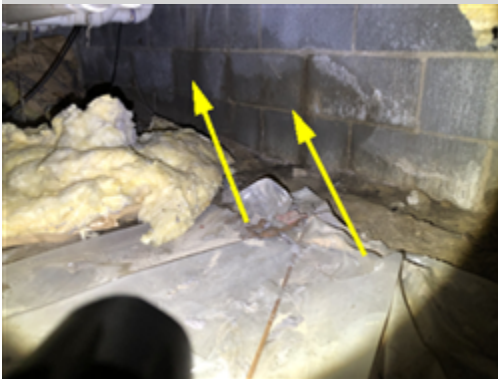
Efflorescence (salt stains) was noted on the foundation walls in the crawl space. The stains indicate that the foundation was been cyclically wet and dry. Water penetration into the foundation area can result in structural damage and undesirable environmental conditions. Water in the foundation area indicates an absent or damaged waterproofing and foundation drain systems. Repairs are needed to prevent water penetration. A licensed general contractor with experience in foundation drainage and water proofing that should be consulted for a complete evaluation to determine the source of the moisture and to make necessary repairs.

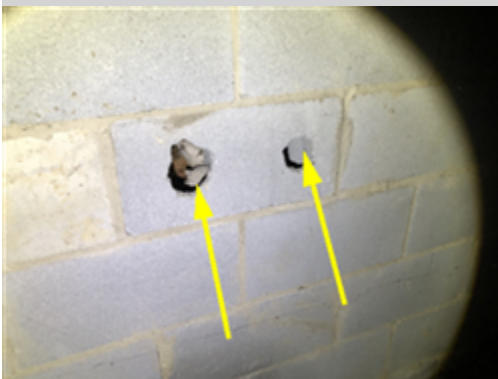
There are two holes in a cinder block brick on the back wall foundation in the crawl space. The purpose of these holes could not be determined at the time of the inspection. It doesn't appear that these holes have impacted the structural fitness of the foundation. If the buyer is concerned about these holes, an engineer should be consulted.

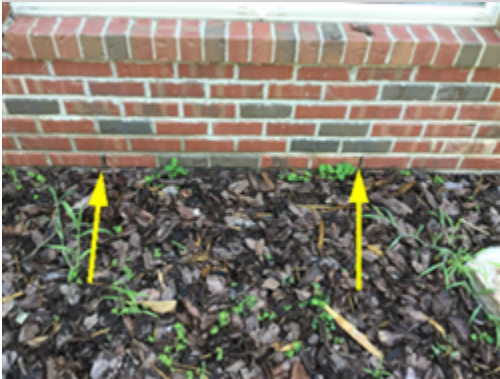
The grading around the foundation at the front of the home has become too high and is partially covering the weep holes. Years of bedding and wood chips has brought the bedding level to or above the slab interior floor level. Incorrect clearance can result in water penetration, drainage, and conditions conducive of insects and decay. A licensed general contractor should be consulted to evaluate and correct the grading as needed for proper clearance and drainage.

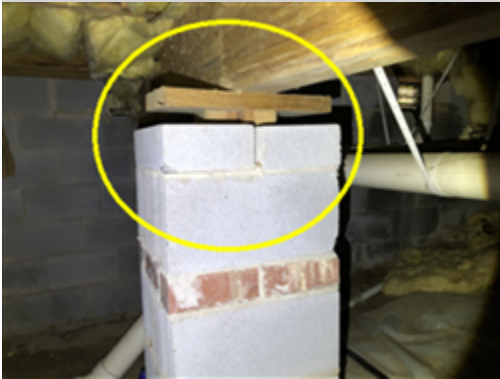
The pier located on the center right side of the crawlspace is not plumb or vertical. This could indicate that the pier is leaning, the pier footing has failed, or that the pier has moved. A licensed general contractor should be consulted for further evaluation and to make necessary repairs.

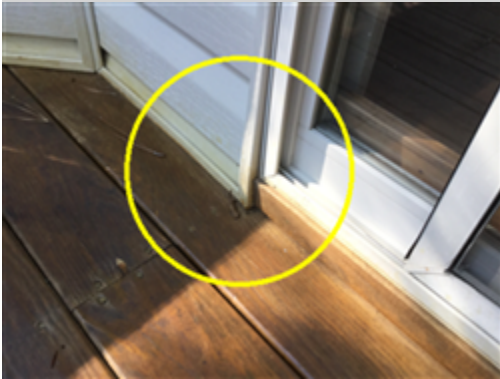
The vinyl siding at the bottom left side of the sliding patio door is damaged and pulling away from the structure. A licensed general contractor should be consulted for complete evaluation to locate and repair all areas of damage.

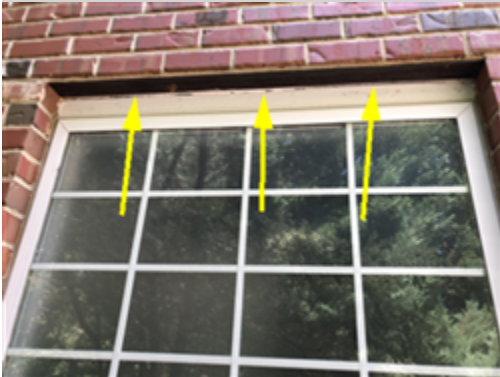
The exterior seal on the top of the master bathroom window is deteriorated and needs repair to stop water penetration and ensure the weather tightness of the window. The homeowner should be asked for disclosure related to the age/extent of the repair and any history of leaks. A licensed general contractor should be consulted to evaluate the extent of the damage and make necessary repairs.

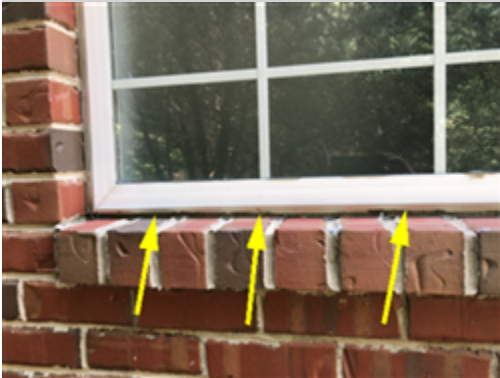
The exterior seal on the bottom of the master bathroom window is deteriorated and needs repair to stop water penetration and ensure the weather tightness of the window. The homeowner should be asked for disclosure related to the age/extent of the repair and any history of leaks. A licensed general contractor should be consulted to evaluate the extent of the damage and make necessary repairs.

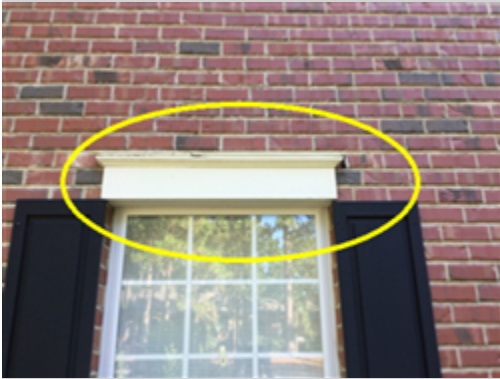
Wood decay was noted above the small garage window. Decay in the windows can result in leaking and water penetration and should be repaired as soon as possible. All windows should be evaluated for damage and or decay behind the trim as repairs are made. A licensed general contractor should be consulted to evaluate the extent of the damage and to make necessary repairs.

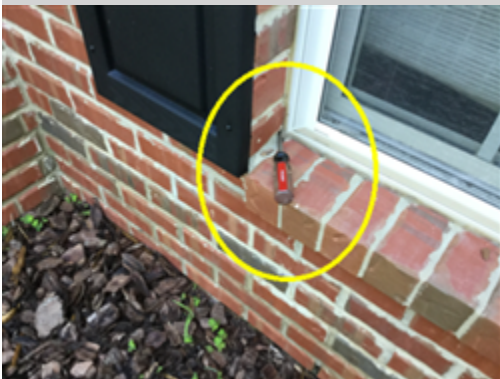
There is a gap at the bottom left side of the garage window between the window and the brick veneer. The gap could indicate a problem with the window installation or movement of the brick veneer. A licensed general contractor should be consulted for a complete evaluation of this and other windows to determine the significance of the concern and outline necessary repairs.

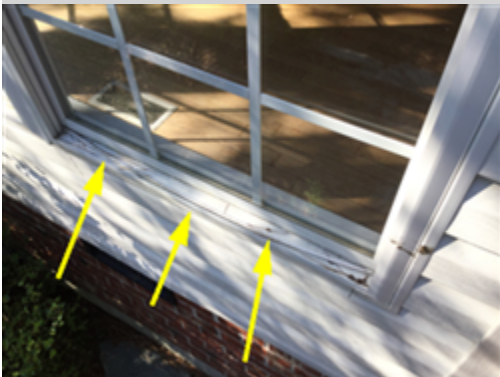
The weather-stripping for the windows on the back deck are damaged. The weather-stripping needs repair/replacement to ensure that the window is weather tight. A licensed general contractor should be consulted for evaluation and repair.

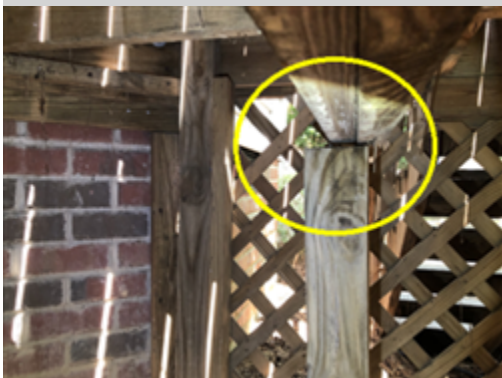
There is a post under the main part of the deck near the staircase that is kicked out and is no longer vertical. Improper deck construction can result in unsafe conditions and possible deck failure. A licensed general contractor should be consulted for a complete evaluation of the deck and to make necessary repairs to ensure the stability and durability of the deck.

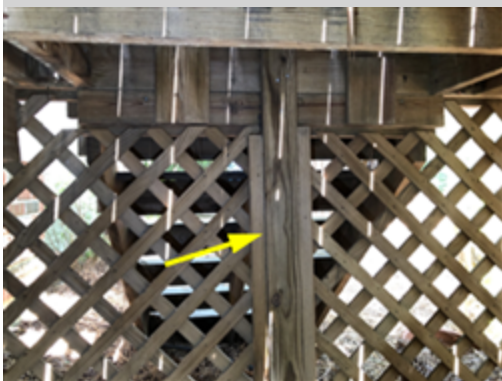
There is a post under the deck attached to the staircase that is no longer vertical. Improper deck construction can result in unsafe conditions and possible deck failure. A licensed general contractor should be consulted for a complete evaluation of the deck and to make necessary repairs to ensure the stability and durability of the deck.

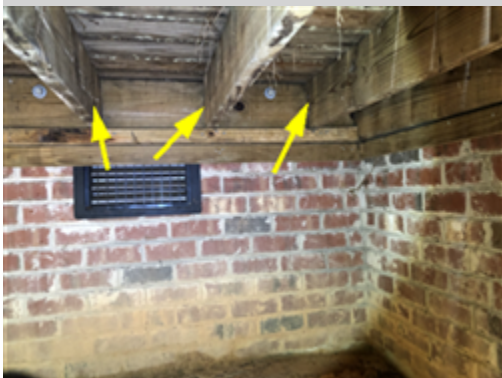
The floor joists for the deck are supported or attached to the home by toe nail connections only. Nails can corrode and fail leaving the floor system unsupported. Improper deck construction can result in unsafe conditions and possible deck failure. A licensed general contractor should be consulted for a complete evaluation of the deck and to make necessary repairs to ensure the stability and durability of the deck.

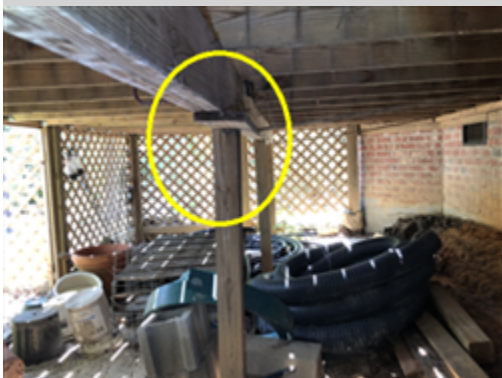
There is a post under the center of the deck that has settled and is now improperly supporting the deck structure. Improper deck construction can result in unsafe conditions and possible deck failure. A licensed general contractor should be consulted for a complete evaluation of the deck and to make necessary repairs to ensure the stability and durability of the deck.

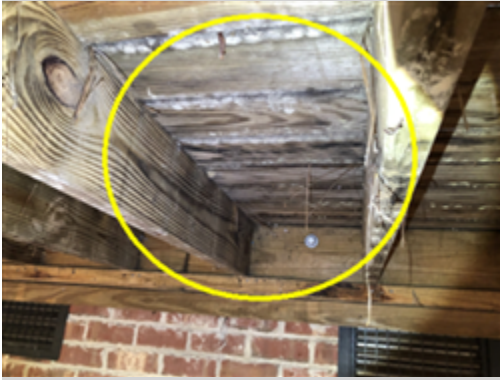
The underside of the wood deck was found to be weathered. A licensed general contractor should be consulted for a complete evaluation of the deck and to make necessary repairs to ensure the stability and durability of the deck.

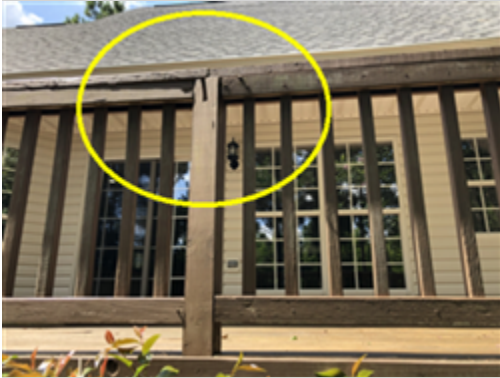
The railing on the back, center of the deck are damaged. A licensed general contractor should be consulted for evaluation of the deck handrail system and to make necessary repairs.

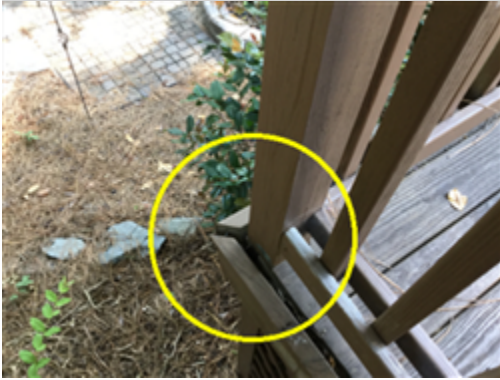
The fascia boards on the rear deck near the stair case are separating. A licensed general contractor should be consulted for a complete evaluation and to make necessary repairs to ensure the boards are secure to prevent cupping and possible trip hazards.

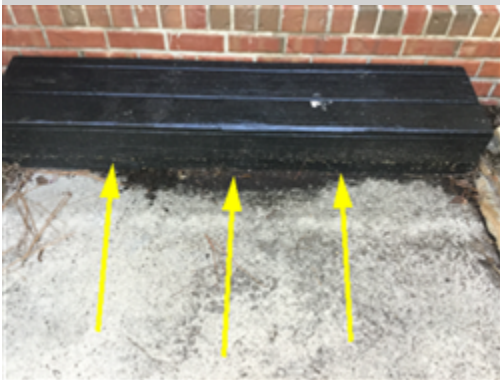
The wood step for the front porch is in direct contact with the cement walkway and there is evidence that water is directed towards the step during rain storms. A licensed general contractor should be consulted for a complete evaluation and to make necessary repairs.

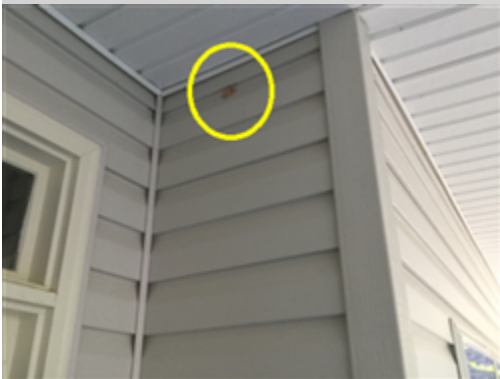
There is evidence of wasps on the exterior siding to the right of the front door. A licensed pest contractor should be consulted for a complete evaluation of the exterior siding to remove this and any other pests on the exterior of the home.

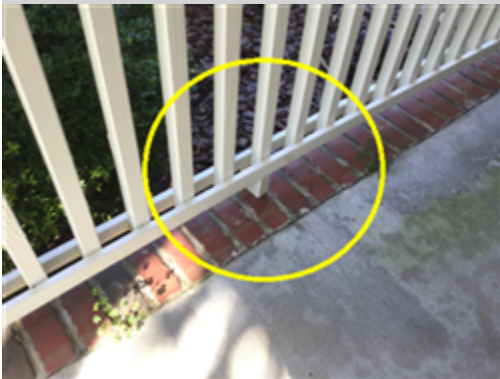
The railings for the front porch are loose and in need of repair or replacement to ensure safe and functional use of the front porch. A licensed general contractor should be consulted for a complete evaluation and to make necessary repairs.

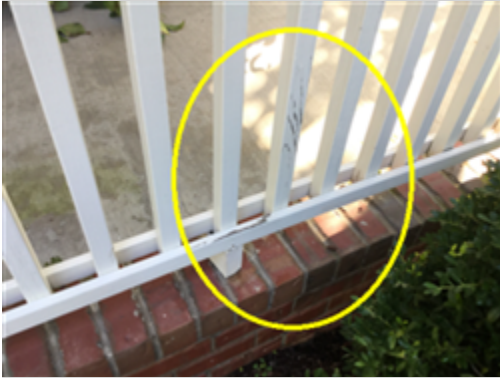
Some of the styles on the front porch columns are weathered and in need of paint to avoid decay and further damage. Repair and painting is needed to prevent further damage and decay. A general repair person should be consulted.

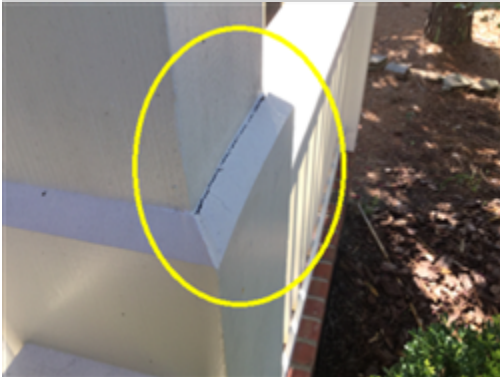
Some of the front porch columns are weathered and starting to split. Repair and painting is needed to prevent further damage and decay. A general repair person should be consulted.

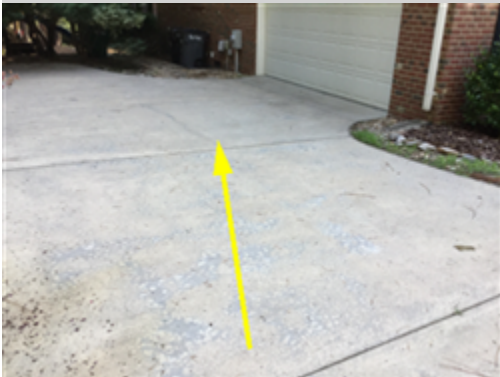
The driveway is sloped to encourage storm drainage to flow toward the home. Efflorescence in the front left area of the crawl space indicate that lot drainage from the driveway area is entering the crawl space area. Drainage into the crawl space can result in damage to the home. A licensed general contractor should be consulted for further evaluation and repair.

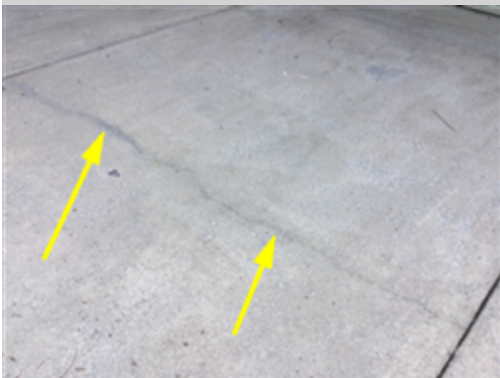
The driveway is cracked. The crack may provide a path for water penetration under the slab. A licensed general contractor should be consulted for further evaluation and repair.

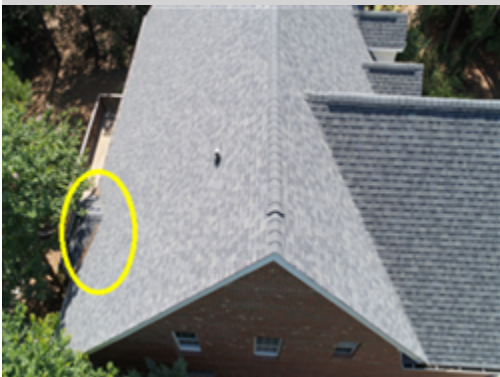
A couple of the valleys on the rear part of the roof covering are covered with a heavy build-up of leaves/pine needles/debris. This limited the inspection of the roof surface. Debris on the roof surface can trap moisture allowing water and debris to travel under the shingle tabs resulting in material failure and leaks. A roofing contractor should be consulted to remove the debris and inspect the shingles/adjacent component for evidence of damage and make necessary repairs.

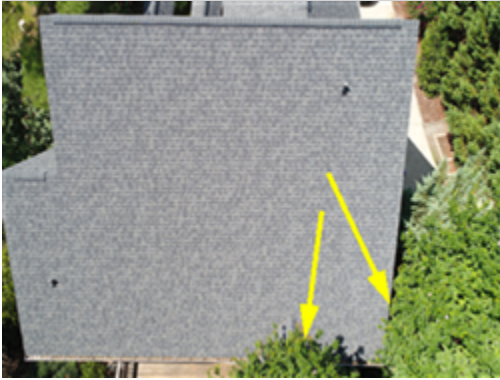
There are a number of tree limbs either in contact with the home/roof or starting to grow over the roof. Keeping trees trimmed and spaced away from the roof, wall cladding and foundation provides air circulation. It is recommended that an arborist be consulted to evaluate and/or trim the trees.

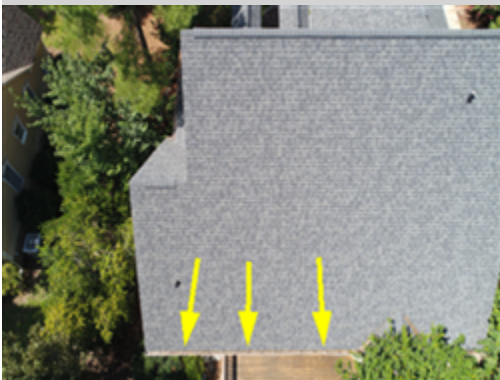
The gutters around the home have excess debris, pine needles and leaves. Direct drainage to the foundation and cladding from the gutter system can result in water penetration into the foundation area and foundation deterioration. A licensed general contractor should be consulted for a complete evaluation and to make necessary repairs.

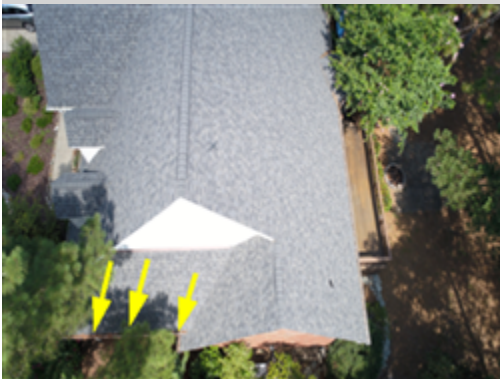
The gutters around the home have excess debris, pine needles and leaves. Direct drainage to the foundation and cladding from the gutter system can result in water penetration into the foundation area and foundation deterioration. A licensed general contractor should be consulted for a complete evaluation and to make necessary repairs.

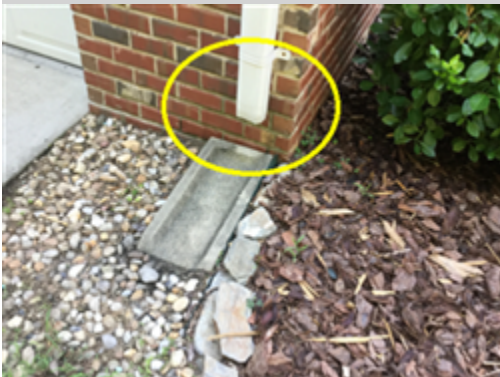
The gutter downspout to the right of the garage is not extended or piped to direct roof drainage away from the foundation. Direct drainage to the foundation and cladding from the gutter system can result in water penetration into the foundation area and foundation deterioration. A licensed general contractor should be consulted for a complete evaluation and to make necessary repairs.

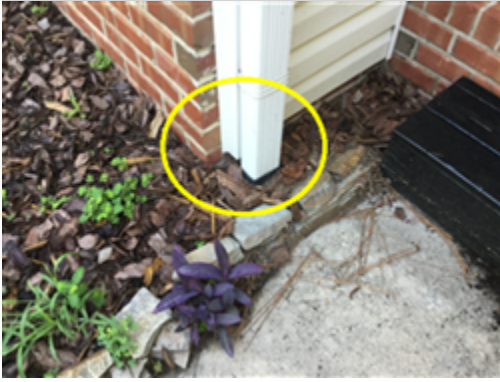
The gutter downspouts around the home are piped underground, however the exits were not located or verified. Direct drainage to the foundation and cladding from the gutter system can result in water penetration into the foundation area and foundation deterioration. A licensed general contractor should be consulted for a complete evaluation to locate and verify the downspout extension and to make necessary repairs.

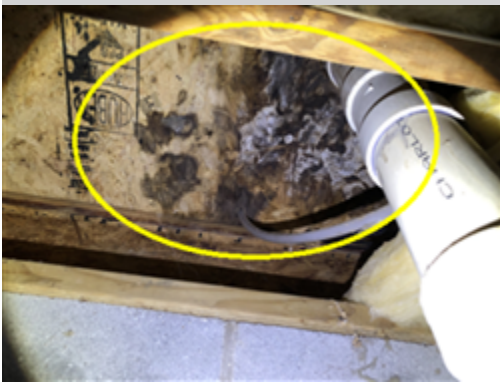
The waste line for the master bathroom toilet is/has been leaking and the long term presence of moisture has caused damage to the surrounding floor structure. When building components have surface discolorations and decay typical of fungal growths, such as mold, mildew, and wood destroying fungi, the home inspection focuses only on moisture concerns and evidence of wood damage. Health issues related to the presence of mold are beyond the scope of the home inspection. If the client has concerns beyond the scope of the home inspection, a certified professional such as an industrial hygienist should be consulted prior to purchasing the home. In addition the waste line needs to be repaired to ensure sanitary conditions. A licensed plumbing contractor should be consulted for a complete evaluation of the waste line systems to determine the general condition of the system and to make necessary repairs.

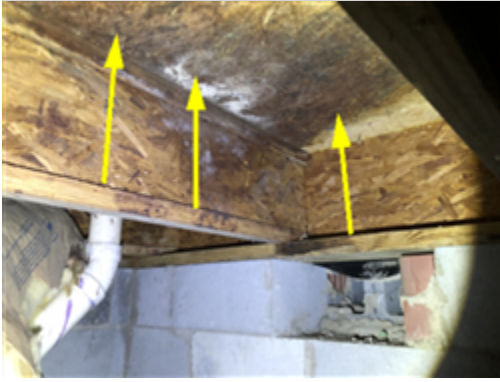
Second image of the waste line for the powder room toilet on the first floor of the home that is/has been leaking and the long term presence of moisture has caused damage to the surrounding floor structure. When building components have surface discolorations and decay typical of fungal growths, such as mold, mildew, and wood destroying fungi, the home inspection focuses only on moisture concerns and evidence of wood damage. Health issues related to the presence of mold are beyond the scope of the home inspection. If the client has concerns beyond the scope of the home inspection, a certified professional such as an industrial hygienist should be consulted prior to purchasing the home. In addition the waste line needs to be repaired to ensure sanitary conditions. A licensed plumbing contractor should be consulted for a complete evaluation of the waste line systems to determine the general condition of the system and to make necessary repairs.

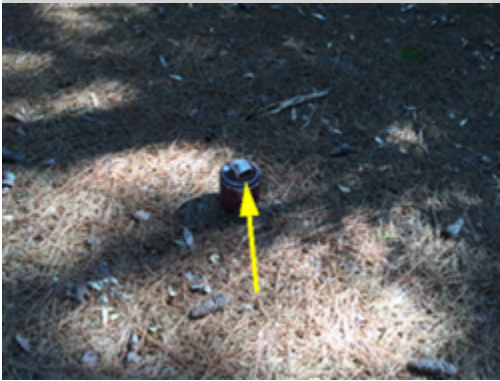
The main waste line is exposed above grade in the back yard of the home. The waste line should be below grade to protect it from damage and extreme temperatures. A licensed plumbing contractor should be consulted for a complete evaluation and to make necessary repairs.

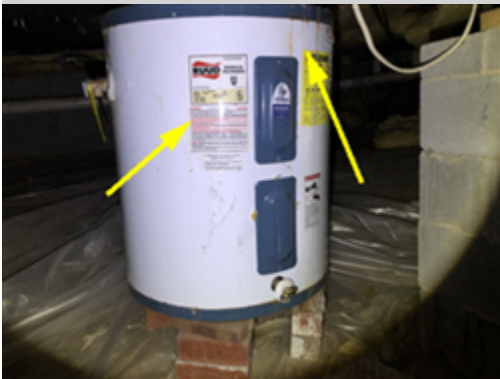
The water heater installed in the crawl space is in poor condition and at the time of the inspection it appeared that the unit was no longer level. A licensed plumbing contractor should be consulted to evaluate the condition of the unit and correct the installation to prevent damage.

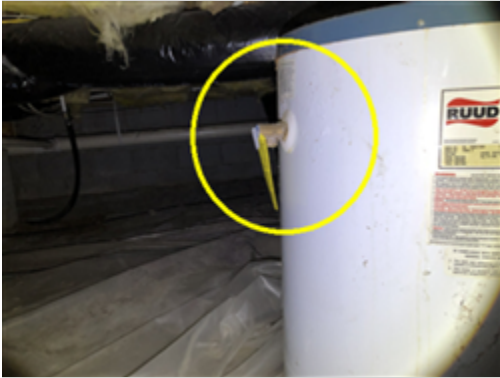
The Temperature Pressure Relief Valve (TPRV) for the water heater is a safety device to prevent the unit from exploding in case of a malfunction. The TPRV is located on the side of the hot water unit to prevent burn injury in the event of a discharge and is required to be piped down to the floor area. The TPRV for this unit does not have an extension, this is a safety issue that needs to be repaired to prevent personal injury or property damage. A plumbing contractor should be consulted for further evaluation and repair.

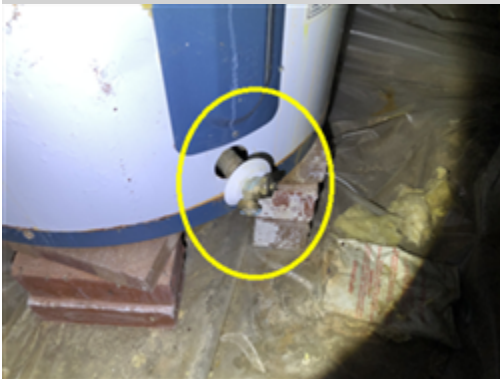
The water heater is equipped with a drain valve in the lower region of the tank. Water heaters need to be drained for maintenance, repair, and replacement. The valve for this unit was noted to be damaged and in need of repair. A licensed plumbing contractor should be consulted to evaluate the system and repair/replace as needed to ensure safe and reliable hot water supply.

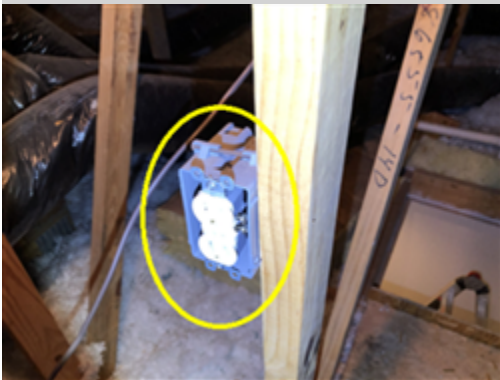
Electrical connections have been made in the attic area without being properly protected in a covered junction box. The open junction leaves electrical conductors exposed and in a hazardous condition. Electrical concerns should be considered fire and safety issues and repaired as soon as possible. The electrical systems and components in the attic are in need of a complete evaluation and repair by a licensed electrical contractor.

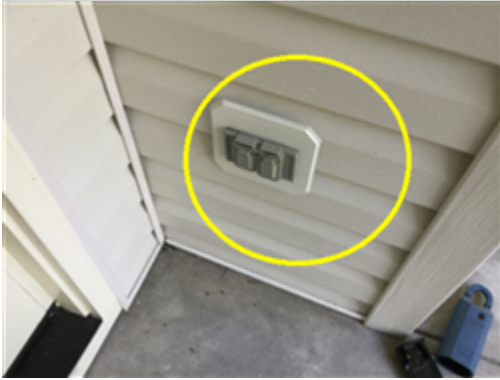
The receptacle on the front porch to the right of the front door is loose. Loose receptacles could result in electrical shock hazard or property damage. A licensed electrical contractor should be consulted for a complete evaluation to determine the significance of this concern and make necessary repairs to correct defects and prevent safety hazards.

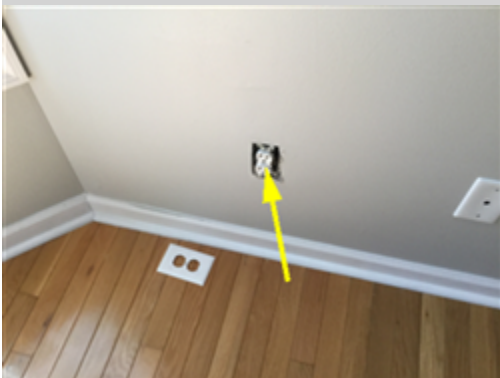
A receptacle in the master bedroom whose protective plate is not installed. This could result in increased shock and fire hazards. A licensed electrical contractor should be consulted to make necessary repairs to ensure safe and proper operation and installation.

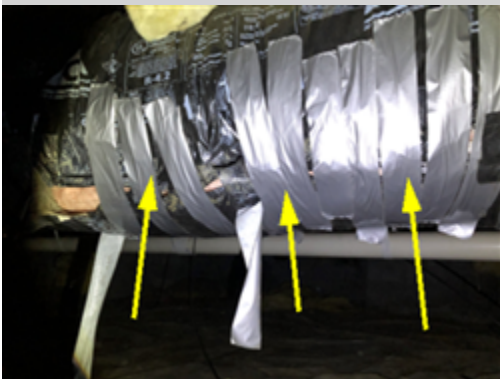
The insulation cover for duct branches near the front of the crawl space are deteriorated, damaged and have been repaired with duct tape. The cover protects the duct structure and holds the insulation in place. An HVAC contractor should be consulted for a complete evaluation and replacement of all damaged duct components to ensure reliable and proper operation of the HVAC system.

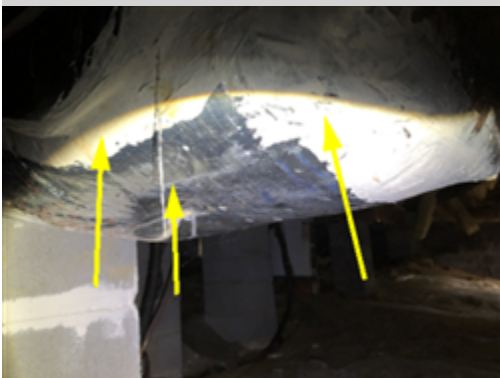
The insulation for the duct system attached to the main Heat Pump unit in the crawl space was noted to be spongy and wet. The source of the moisture and any related concerns need to be addressed to ensure proper air flow and prevent contamination of the air supply. An HVAC contractor should be consulted for a complete evaluation and replacement of all damaged duct components to ensure reliable and proper operation of the HVAC system.

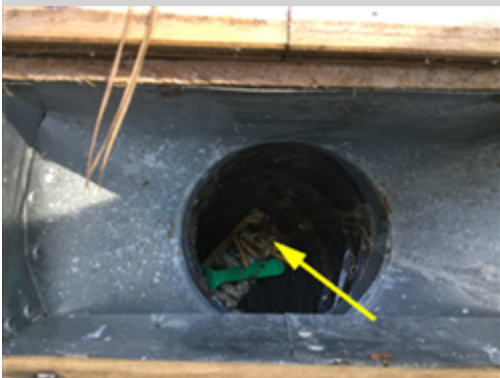
Many of the main floor ducts are filled with garbage and debris. The debris reduces the air flow and contaminates the air supply. An HVAC contractor should be consulted for a complete evaluation and replacement of all damaged duct components to ensure reliable and proper operation of the HVAC system.

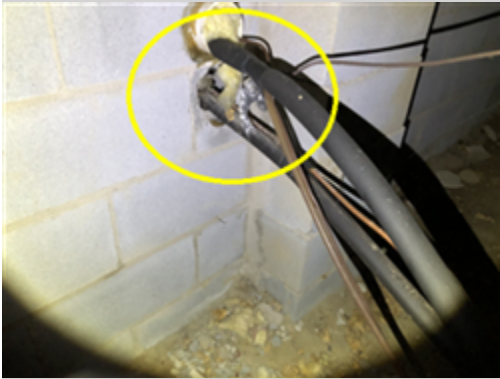
The condensate drain line has been improperly installed directly into the main sewer line. This could result in sewer backing up into the air handler resulting in cross contamination where germs could enter the air supply. A HVAC contractor should be consulted to inspect the air handler for contamination or wet insulation and correct the condensate drain line to ensure drainage. A licensed plumbing contractor should be consulted to repair/replace the section of the waste line where the opening was improperly installed.

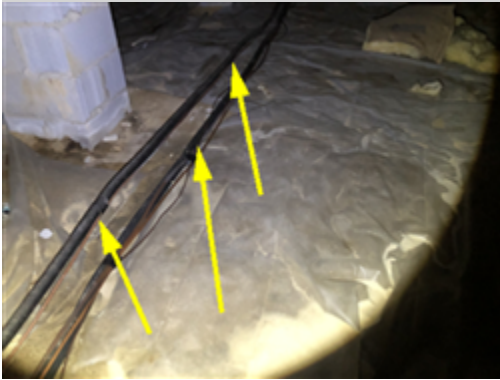
The AC refrigerant line sets that connects the outside compressor units to the interior air handler are in direct contact with the ground of the crawl space. An HVAC contractor should be consulted for a complete evaluation and repair of the system to ensure reliable and proper operation of the HVAC system.

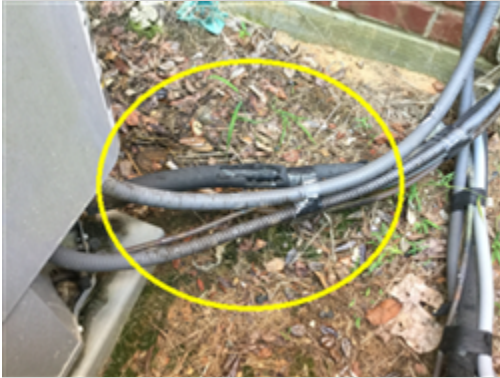
The large line of the AC refrigerant line set that connects the Carrier outside compressor unit to the interior air handler is required to be insulated to reduce condensation and associated water damage. The AC line insulation is missing/damaged near the connection to the unit. An HVAC contractor should be consulted for a complete evaluation and repair of the system to ensure reliable and proper operation of the HVAC system.

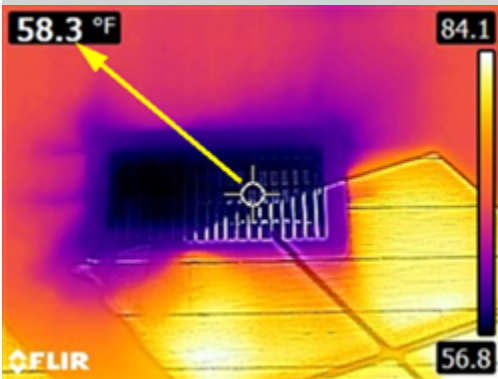
Thermal image of the temperature variance between the return/supply air for the main floor AC condensing unit. The temperature variance between the return/supply air was 12.4 degrees(F). This variance was less than typically expected, a complete evaluation by an HVAC contractor is needed.

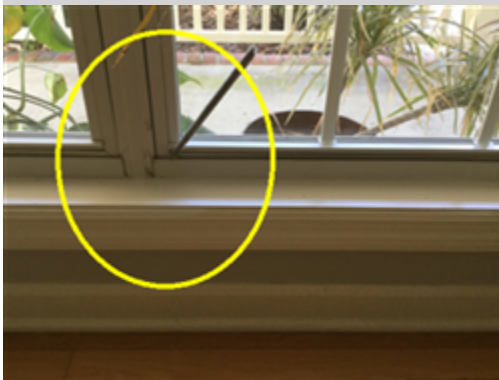
The window in the dining room is damaged and needs further evaluation and repair. All windows should be evaluated as repairs are made. A licensed general contractor should be consulted. Refer to the exterior section of the report.

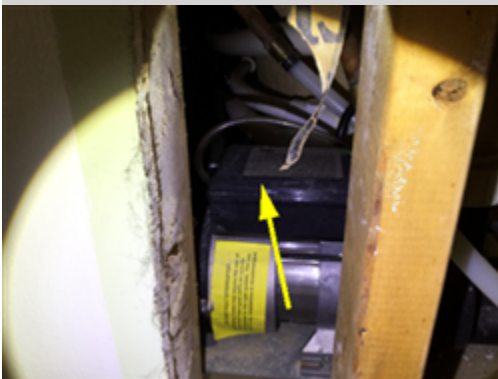
The whirlpool pump motor has not been bonded as required for homes with copper or metal plumbing. A licensed electrical contractor should be consulted for evaluation and repair to ensure safe and proper operation.
