Property Inspection Report

Report Number: 07-25-2019

345 Sample Street
Pinehurst, North Carolina 28374

Date of Inspection: Thursday, July 25, 2019

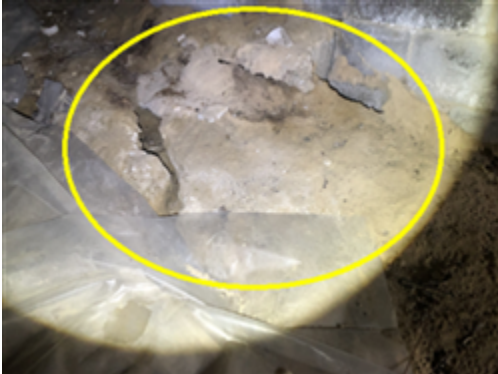
(A1 - 1.1) Main House

The soil on the left side of the crawl space is severely eroded and has left a portion of the crawl space foundation unsupported. An engineer should be consulted to determine the significance of the concerns and for a full evaluation of the foundation to outline necessary repairs.

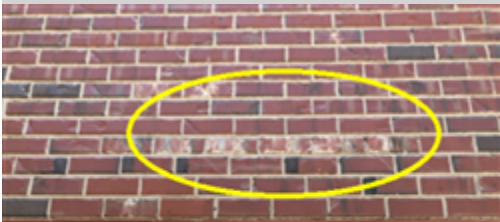
(B1 - 1.1) Main House

It appears that a small area of bricks above the garage door have been repaired/new mortar applied. Deteriorated mortar could indicate defects related to age, water penetration, or improper installation. Homeowner disclosure and a masonry contractor should be consulted for further evaluation of the brick veneer and to repair all loose, soft, missing mortar.

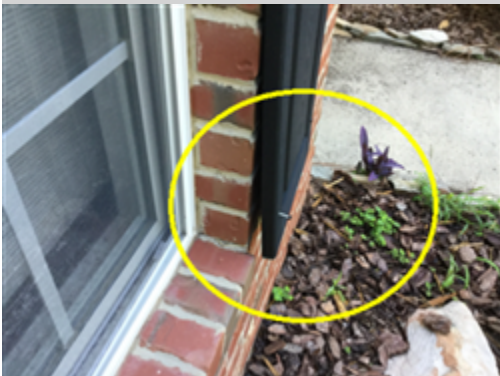
(B2 - 2.3) Garage Windows

The shutter to the right of the large garage window is not secure to the exterior of the home. A general contractor should be consulted to ensure this and other shutter's are properly secured to the home.

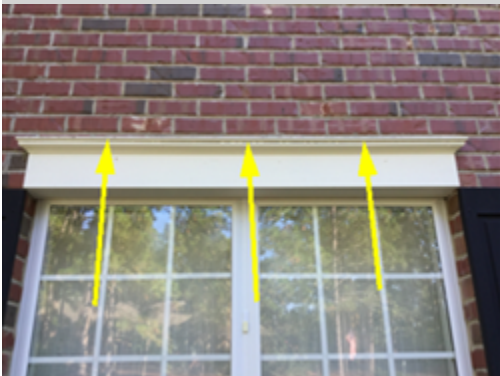
(B2 - 2.4) Garage Windows

Wood decay was noted above the large garage window. Decay in the windows can result in leaking and water penetration and should be repaired as soon as possible. All windows should be evaluated for damage and or decay behind the trim as repairs are made. A licensed general contractor should be consulted to evaluate the extent of the damage and to make necessary repairs.

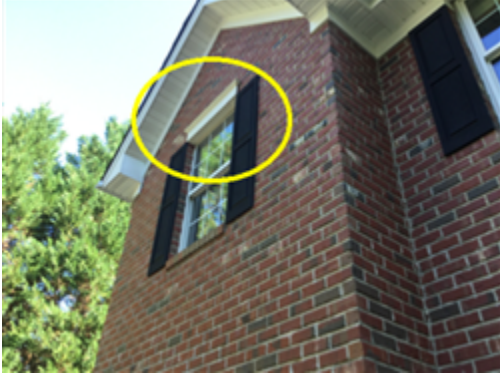
(B2 - 3.1) Front Left Bedroom Window

Wood decay was noted above the front left bedroom window. Decay in the windows can result in leaking and water penetration and should be repaired as soon as possible. All windows should be evaluated for damage and or decay behind the trim as repairs are made. A licensed general contractor should be consulted to evaluate the extent of the damage and to make necessary repairs.

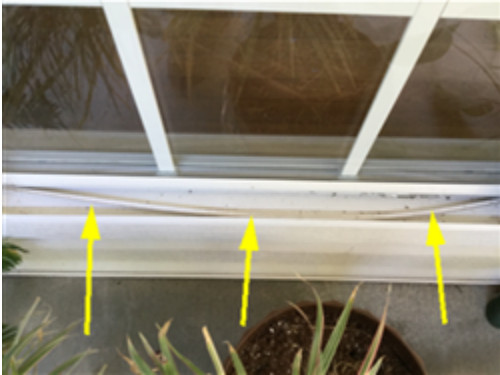
(B2 - 4.1) Front Porch Windows

The weather-stripping for the windows on the front porch are damaged. The weather-stripping needs repair/replacement to ensure that the window is weather tight. A licensed general contractor should be consulted for evaluation and repair.

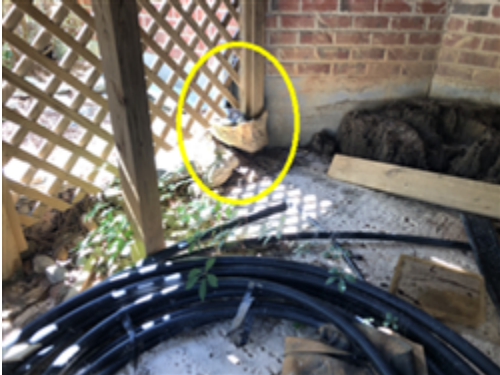
(B3 - 1.6) Deck

Some of the wood deck posts are supported by poured cement footings. The poured footing on the right side of the deck nearest the home is no longer in contact with the ground and therefore not providing the necessary and required support. Incorrect post footings could allow the structure to move or fail. A licensed general contractor should be consulted for a complete evaluation of the deck and to make necessary repairs to ensure the stability and durability of the deck.

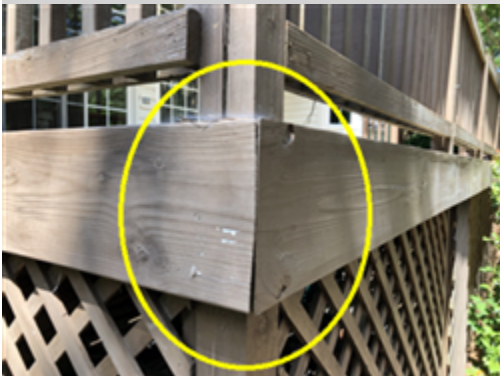
(B3 - 1.7) Deck

The fascia boards on the back right area of the rear deck are separating. A licensed general contractor should be consulted for a complete evaluation and to make necessary repairs to ensure the boards are secure to prevent cupping and possible trip hazards.

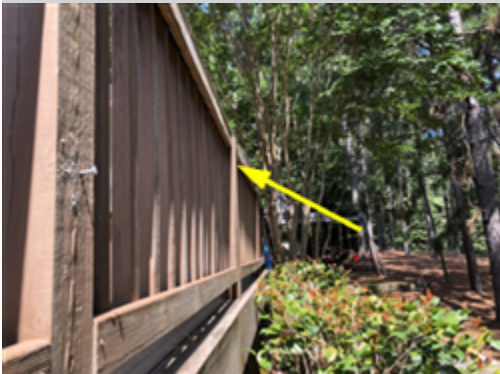
(B3 - 1.8) Deck

The railings on the back of the deck are loose in a couple of areas and present a safety/fall hazard. A licensed general contractor should be consulted for evaluation of the deck handrail system and to make necessary repairs.

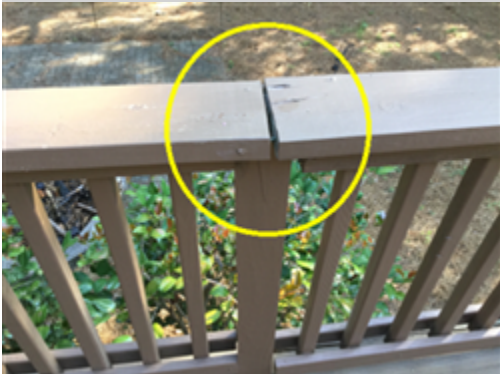
(B3 - 1.10) Deck

The railing on the back, center of the deck are damaged. A licensed general contractor should be consulted for evaluation of the deck handrail system and to make necessary repairs.

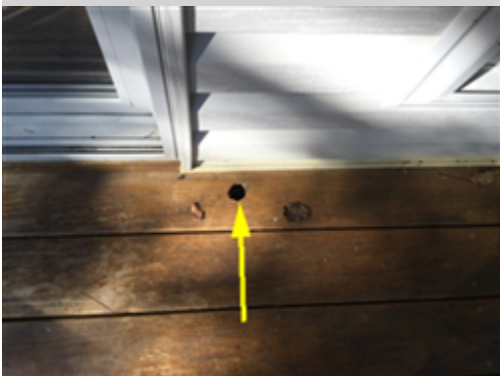
(B3 - 1.11) Deck

There is a hole in the wood deck near the sliding patio door. The owner should be asked for disclosure regarding the reason for this hole.

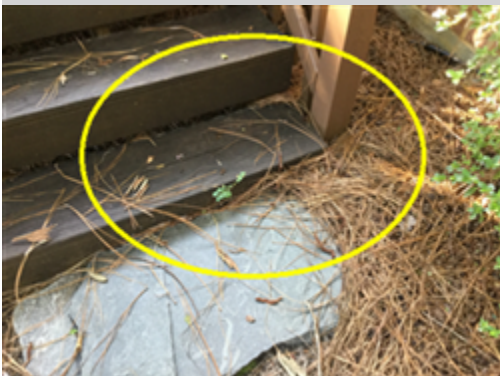
(B3 - 1.12) Deck

The bottom step to the rear wood deck has settled, is in direct contact with the ground and is decayed/deteriorating. A licensed general contractor should be consulted to review the steps and repair as needed to ensure safe access and egress.

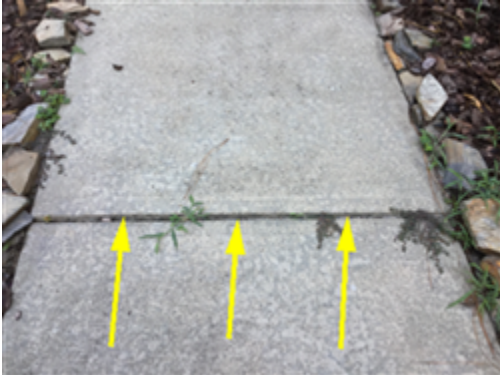
(B4 - 2.1) Sidewalk

The sidewalk is raised, cracked, uneven along the walking surface resulting in a trip hazard. A licensed general contractor should be consulted for further evaluation and repair.

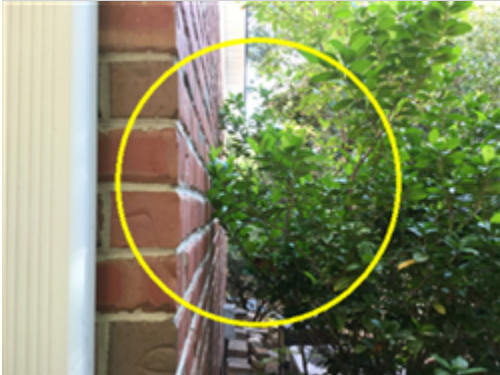
(B5 - 1.1) Vegetation

The vegetation around the perimeter of the home is over grown and blocks the air circulation around the home. The growth also limited the inspection access. A landscaping company should be consulted to correct the over growth and the inspection should be completed prior to purchase.

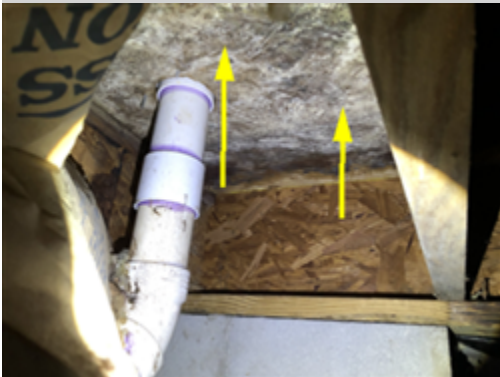
(D2 - 1.2) Crawl Space

The waste line for the powder room toilet on the first floor of the home is/has been leaking and the long term presence of moisture has caused damage to the surrounding floor structure. When building components have surface discolorations and decay typical of fungal growths, such as mold, mildew, and wood destroying fungi, the home inspection focuses only on moisture concerns and evidence of wood damage. Health issues related to the presence of mold are beyond the scope of the home inspection. If the client has concerns beyond the scope of the home inspection, a certified professional such as an industrial hygienist should be consulted prior to purchasing the home. In addition the waste line needs to be repaired to ensure sanitary conditions. A licensed plumbing contractor should be consulted for a complete evaluation of the waste line systems to determine the general condition of the system and to make necessary repairs.

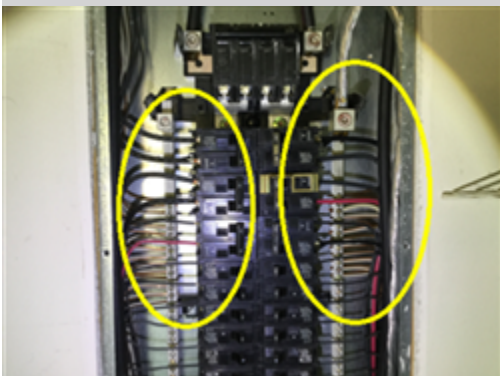
(E2 - 1.1) Main Panel (Garage)

There are a number of breakers on the left/right side of the electrical panel has a conductor and ground wire attached to the power screw. This condition presents a safety hazard that could result in interrupted service, property damage, and serious personal injury. A licensed electrical contractor should be consulted for further evaluation to verify the breaker rating and to make necessary repairs.

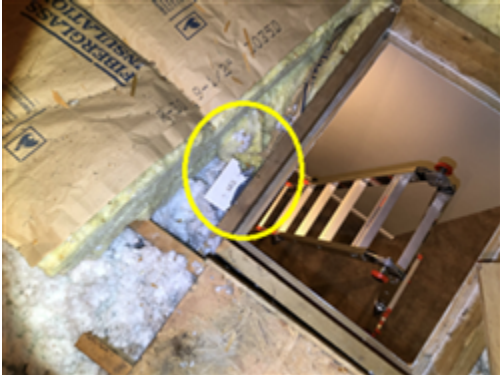
(E5 - 1.1) Attic

The plate for the light switch used to turn on the attic light is broken. A licensed electrical contractor should be consulted for a complete evaluation to determine the significance of this concern and make necessary repairs to correct defects and prevent safety hazards.

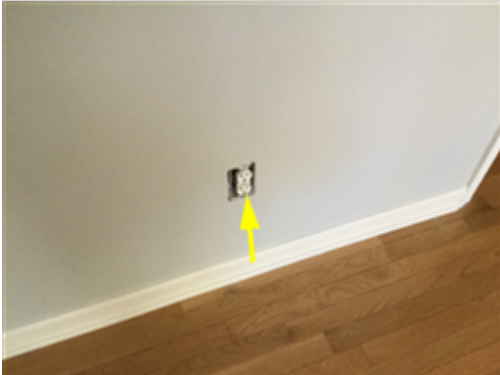
(E5 - 3.1) Dining Room

There are two receptacles in the dining room that do not have a protective cover plate. This could result in increased shock and fire hazards. A licensed electrical contractor should be consulted to make necessary repairs to ensure safe and proper operation and installation.

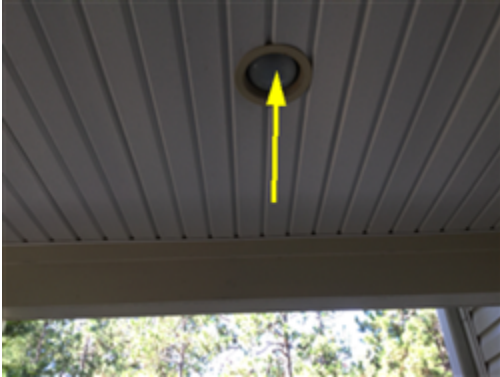
(E5 - 5.1) Front Porch

One of the front porch lights was not functional when tested. This could indicate a defective bulb or other more serious problem such as faulty wiring or a defective fixture. A licensed electrical contractor should be consulted for further evaluation and repair.

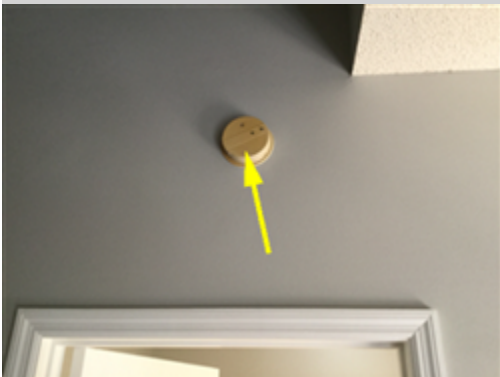
(E5 - 6.1) Family Room

This home has a limited number of smoke detectors as compared to current standards and the inspector could not confirm the presence of Carbon Monoxide detectors. Currently it is recommended that a smoke/carbon dioxide detector be installed at each floor level in the home and in each sleeping room. Correction is recommended.

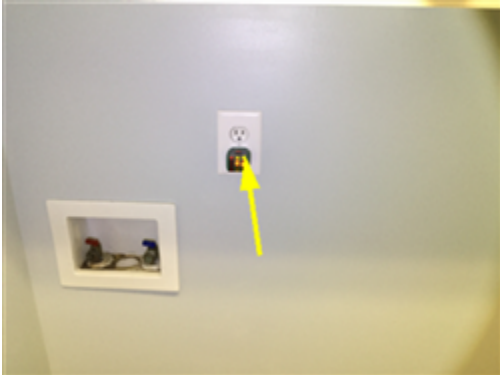
(E5 - 8.1) Laundry

The home was built before GFCI circuits were required to protect all electrical receptacles located within six feet of water. GFCI circuits add an important safety feature to electrical systems. The buyer should consider upgrading the electrical system to include GFCI protection.

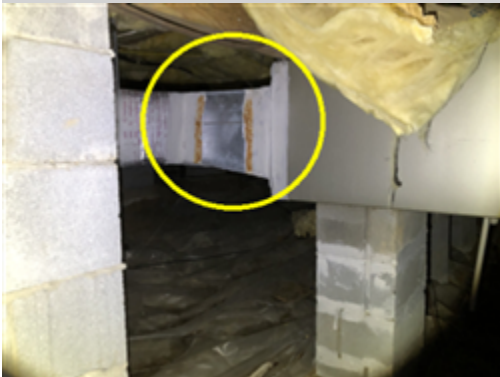
(F1 - 1.1) Heating Unit #1-Crawl

Parts of the metal housing for the Heating Unit in the crawl space has visible areas of rust that is likely due to long term presence of moisture. An HVAC contractor should be consulted for a complete evaluation and to make necessary repairs to ensure safe, reliable, and proper operation of the HVAC system.

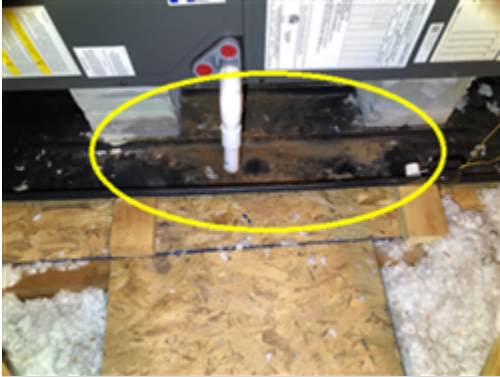
(F1 - 2.1) Heating Unit #2-Attic

The auxiliary drain pan underneath the Heat Pump Unit in the attic has evidence of rust. This condition indicates a history of improper drainage of the system condensate water. Improper drainage of the condensate water can result in system and property damage. An HVAC contractor should be consulted for a complete evaluation and to make necessary repairs to ensure safe, reliable, and proper operation of the HVAC system.

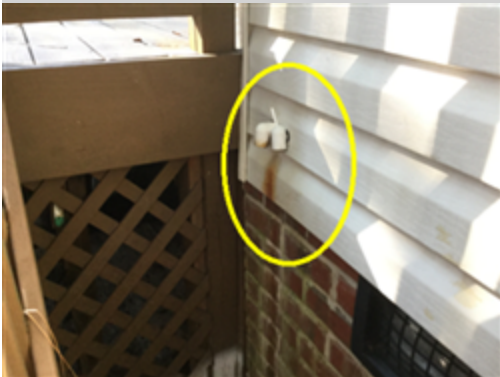
(F1 - 2.2) Heating Unit #2-Attic

During the inspection, there is a rust stain on the exterior of the home where the drain exit for the AC condensate exits the crawl space. An HVAC contractor should be consulted for a complete evaluation and repair of the system to ensure reliable and proper operation of the HVAC system.

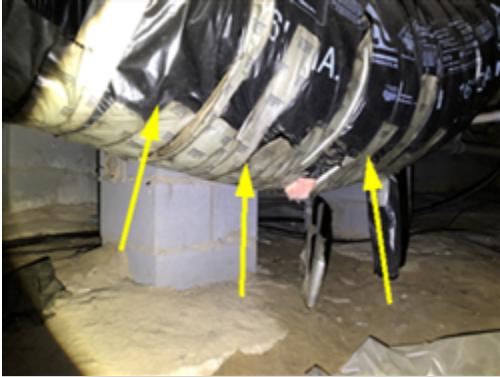
(F2 - 1.1) Heating Unit #1-Crawl

The insulation cover for duct branches near the front of the crawl space are deteriorated, damaged and have been repaired with duct tape. The cover protects the duct structure and holds the insulation in place. An HVAC contractor should be consulted for a complete evaluation and replacement of all damaged duct components to ensure reliable and proper operation of the HVAC system.

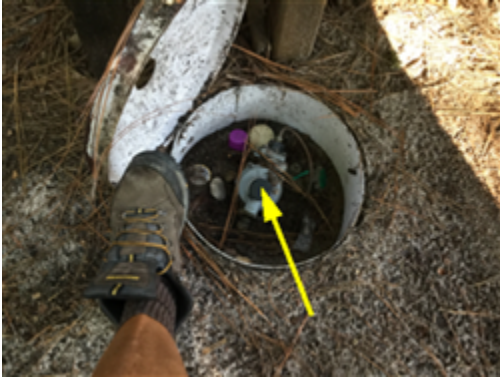
(F3 - 1.1) Exterior

The home has an underground propane storage tank. Storage tanks are either leased from the fuel supplier or owned by the homeowner. The tank was not visible and therefore was not inspected. The buyer should request more information concerning the storage tank, service requirements and ownership.

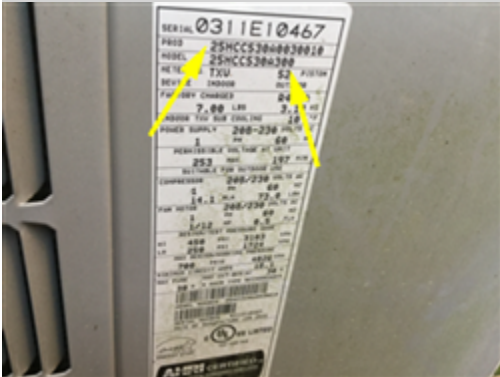
(G1 - 1.4) Cooling Unit #1-Exterior Right Side

The large line of the AC refrigerant line set that connects the Carrier outside compressor unit to the interior air handler is required to be insulated to reduce condensation and associated water damage. The AC line insulation is missing/damaged near the connection to the unit. An HVAC contractor should be consulted for a complete evaluation and repair of the system to ensure reliable and proper operation of the HVAC system.

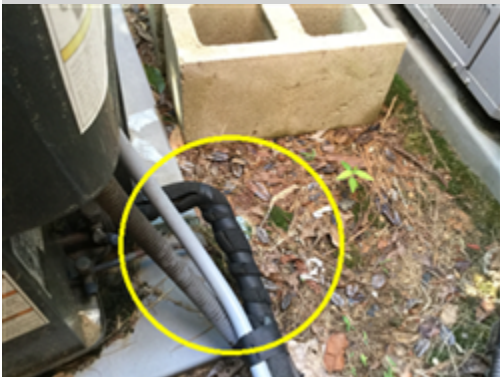
(G1 - 2.1) Cooling Unit #2-Exterior Right Side

The large line of the AC refrigerant line set that connects the Goodman outside compressor unit to the interior air handler is required to be insulated to reduce condensation and associated water damage. The AC line insulation is missing/damaged near the connection to the unit. An HVAC contractor should be consulted for a complete evaluation and repair of the system to ensure reliable and proper operation of the HVAC system.

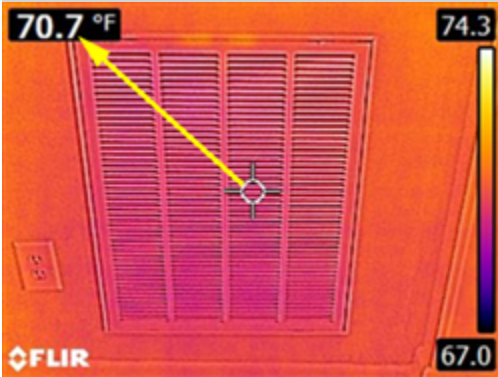
(G2 - 1.1) Cooling Unit #1

Thermal image of the temperature variance between the return/supply air for the main floor AC condensing unit. The temperature variance between the return/supply air was 12.4 degrees(F). This variance was less than typically expected, a complete evaluation by an HVAC contractor is needed.

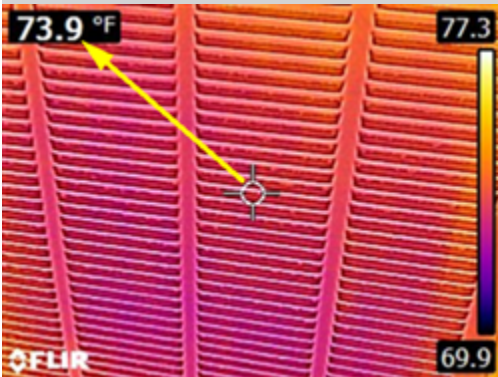
(G2 - 2.1) Cooling Unit #2

Thermal image of the temperature variance between the return/supply air for the main floor AC condensing unit. The temperature variance between the return/supply air was 11.7 degrees(F). This variance was less than typically expected, a complete evaluation by an HVAC contractor is needed.

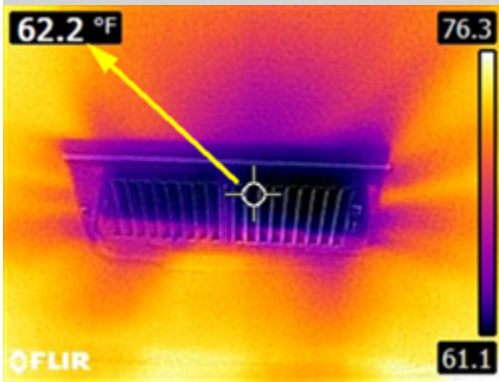
(G2 - 2.2) Cooling Unit #2

Thermal image of the temperature variance between the return/supply air for the main floor AC condensing unit. The temperature variance between the return/supply air was 11.7 degrees(F). This variance was less than typically expected, a complete evaluation by an HVAC contractor is needed.

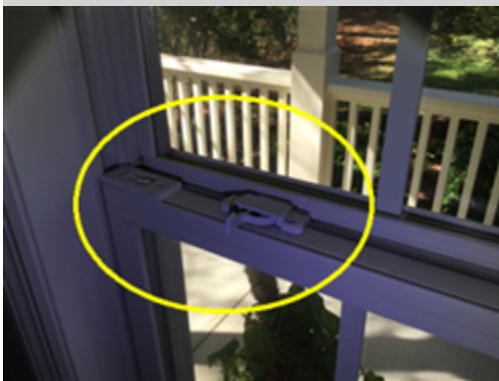
(H1 - 1.2) Dining Room

The window on the left hand side of the dining room needs repair to ensure proper operation. The window did not properly latch, lock, open. All windows should be evaluated as repairs are made. A licensed general contractor should be consulted to review the installation and repair as needed to ensure safe and secure operation.

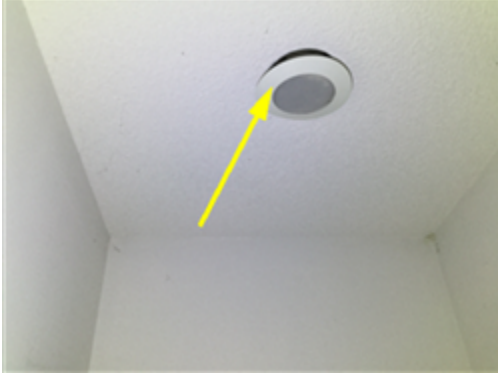
(H1 - 2.1) Pantry

The light fixture in the pantry off the kitchen is damaged. Damaged fixtures could result in improper operation and electrical hazards. A licensed electrical contractor should be consulted for further evaluation and repair.

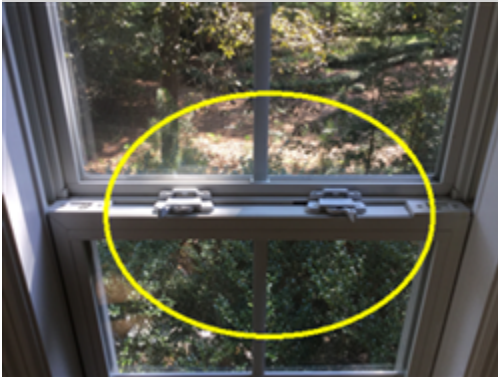
(H1 - 3.1) Breakfast Nook

The single window to the right of the breakfast nook looking to the back yard is damaged and doesn't open/close properly. This could indicate a problem with the window and or trim installation. A licensed general contractor should be consulted to determine the cause of the separation and repair as needed.

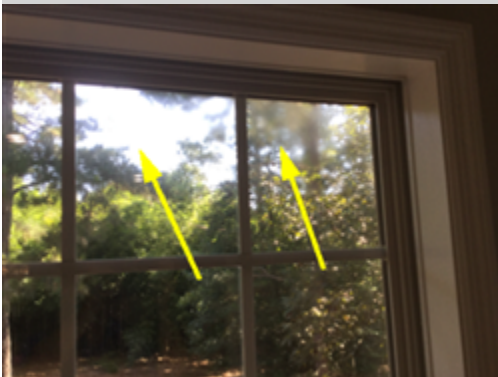
(H1 - 3.2) Breakfast Nook

At least two of the windows in the breakfast nook have a cloudy or hazed appearance. The cloudy appearance indicates that the gas seal between the double glass panes has been jeopardized reducing the energy rating of the windows. The severity of the hazing varies with season and time of the day; therefore, all damaged windows may not have been visible at the time of the inspection. All windows should be evaluated as repairs are made. A licensed general contractor should be consulted.

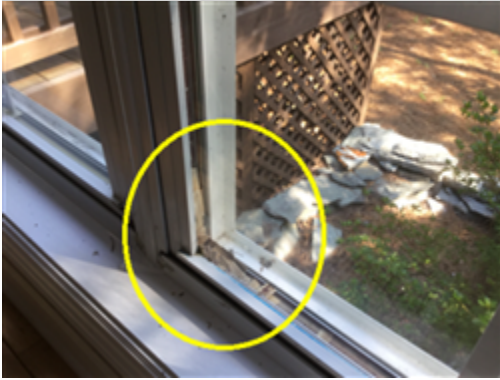
(H1 - 3.3) Breakfast Nook

At least two of the windows in the breakfast nook area have started to decay inside the frame area and there is a lot of debris present at the bottom inside of the panes. All windows should be evaluated as repairs are made. A licensed general contractor should be consulted.

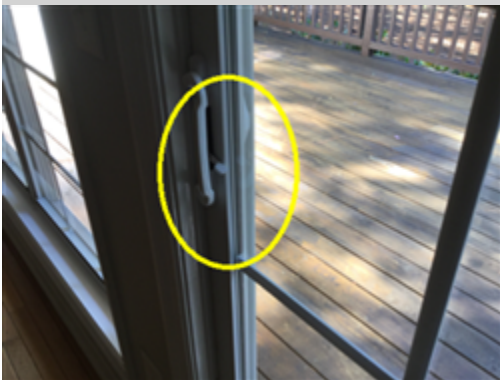
(H1 - 4.1) Family Room

The locking mechanism for the sliding patio door is damaged and does not operate as intended. The door needs repair/replacement to ensure that the it closes securely and operates properly. A general repair specialist or licensed general contractor should be consulted for evaluation and repair.

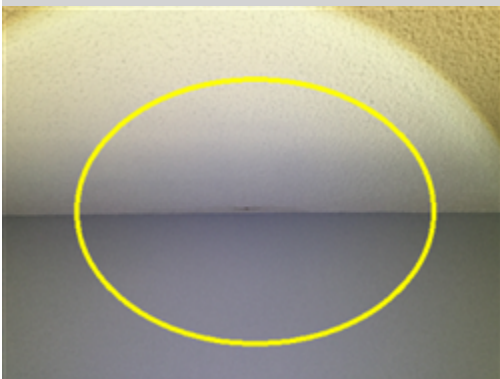
(H1 - 4.2) Family Room

The ceiling above the sliding patio door in the family room is cracked. No related concerns were noted throughout the adjacent inspection areas. The buyer should review the area of concern. If additional concerns or questions are present, invasive inspection and repair will be needed. A general repair specialist should be consulted for evaluation and repair to ensure that the ceiling is secure.

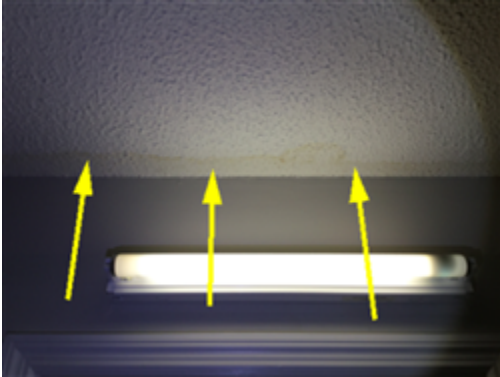
(H1 - 5.1) Upstairs Bedroom

Stains on the ceiling in a bedroom closet upstairs indicate a history of a leak. At the time of the inspection it was not possible to determine if the condition was due to an active or past occurrence. Further investigation by a repair specialist and owner disclosure is recommended. Refer to the Attic section of the report.

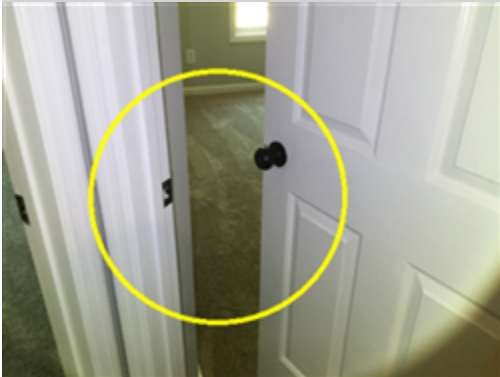
(H1 - 6.1) Front Left Upstairs Bedroom

The door lock assembly in the front left upstairs bedroom is damaged/not functional. The lock could not be engaged to secure the door. The lock needs repair/replacement to ensure that the door closes securely and operates properly. A general repair specialist or licensed general contractor should be consulted for evaluation and repair.

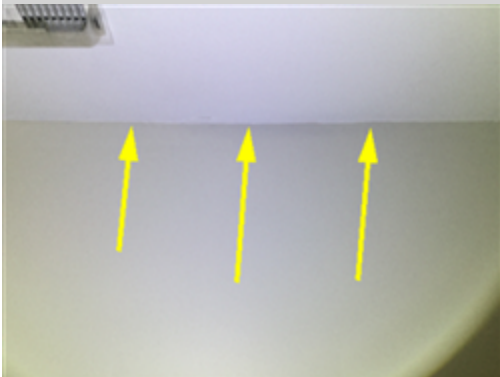
(H1 - 7.1) Front Right Bedroom

Stains on the ceiling in the large front right upstairs bedroom indicate a history of a leak. At the time of the inspection it was not possible to determine if the condition was due to an active or past occurrence. Further investigation by a repair specialist and owner disclosure is recommended. Refer to the Attic section of the report.

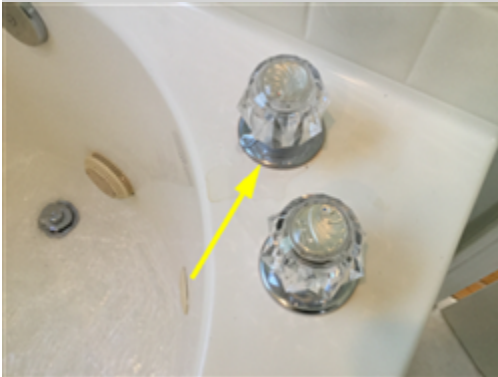
(H3 - 1.1) Bathroom: Master

The whirlpool tub faucet is dripping/leaking. A licensed plumbing contractor should be consulted for evaluation and repair to ensure proper service.

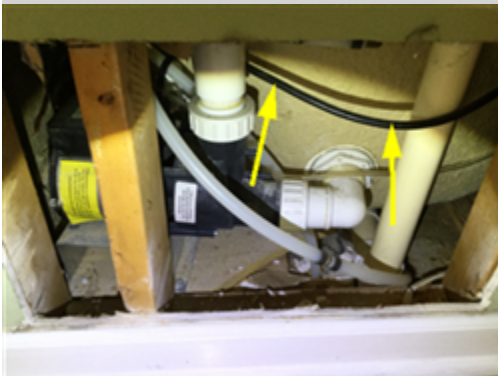
(H3 - 1.3) Bathroom: Master

The whirlpool could not be verified to be protected by a GFCI circuit. A GFCI is needed to ensure safe and functional operation of the tub. A licensed electrical contractor should be consulted for evaluation and repair.

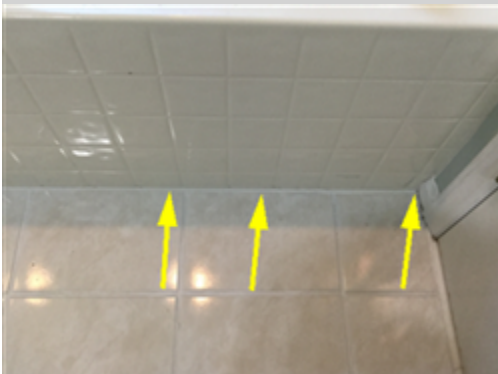
(H3 - 1.4) Bathroom: Master

The grout/caulking where the tile meets the whirlpool tub needs repair. New caulking has been installed below the entrance to the shower stall. The purpose of the grout/caulk is to fill the space between the tiles and to protect the bond between the tile and the mortar base. A tile installation/repair company should be consulted to evaluate the tile system to determine the significance of the concern and make necessary repairs.

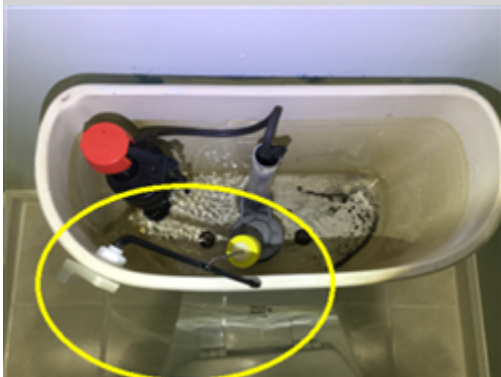
(H3 - 1.5) Bathroom: Master

The toilet flush valve is not operating properly. This could result in improper functioning, flooding and waste of water. A licensed plumbing contractor should be consulted for evaluation and repair.

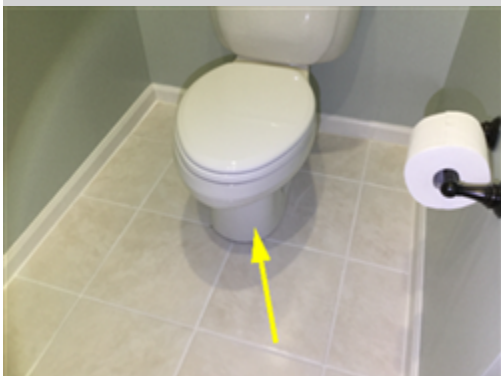
(H3 - 1.6) Bathroom: Master

The toilet in the master bathroom rocks and is not secure to the floor. Movement of the toilet can result in leaks and damage. A licensed plumbing and general contractor should be consulted for evaluation and repair.

NOTE: refer to the plumbing section of the report to see images taken from the crawl space of damage to the underlying framing in this area of the home.

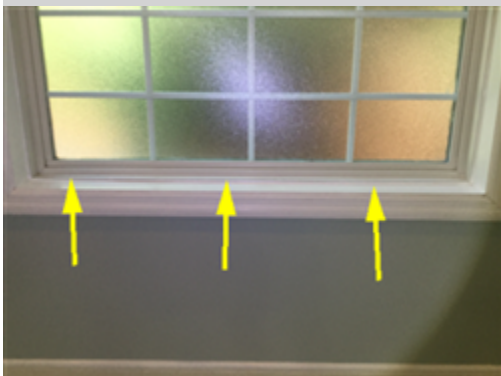
(H3 - 1.7) Bathroom: Master

A window is present in the shower/tub area. The window is being exposed to constant water contact and could allow water penetration into the wall or framing areas. The window glass also presents a safety issue related to breakage and personal injury in the event that a person should slip or fall and impact the window. A licensed general contractor should be consulted to review the window and adjacent framing components for concerns related to water penetration, possible hidden damage, and safety concerns related to the glass in the shower area.

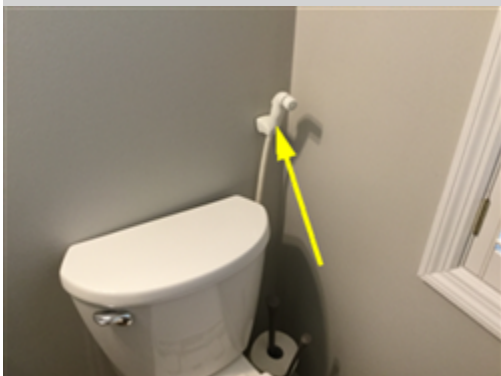
(H3 - 2.1) Powder Room

There is a water sprayer installed in the main floor powder room. This is not a normal plumbing installation. The seller should be asked to disclose the purpose for this installation.

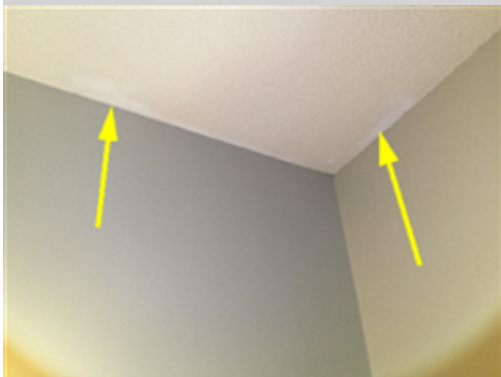
(H3 - 2.2) Powder Room

Evidence suggests that the ceiling in the powder room has been repaired/painted. The owner should be asked for disclosure related to the extent of any related repairs, leaks or problems and the reason the ceiling was painted. New paint can limit the inspection as all history of defects or concerns are not visible.

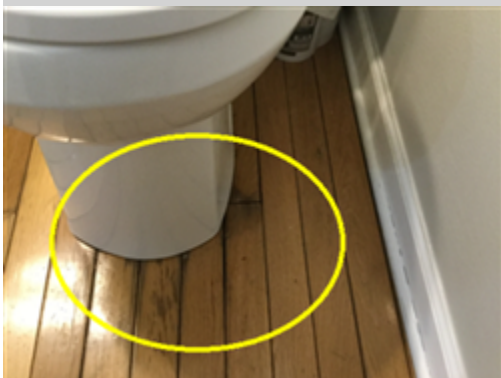
(H3 - 2.3) Powder Room

The wood flooring around the toilet in the main floor powder room shows evidence of a previous water leak. A licensed general contractor should be consulted for an invasive investigation to determine the source of the water penetration and the extent of the decay to prevent further damage and undesirable conditions.

NOTE: refer to the plumbing section of the report to see images taken from the crawl space of damage to the underlying framing in this area of the home.

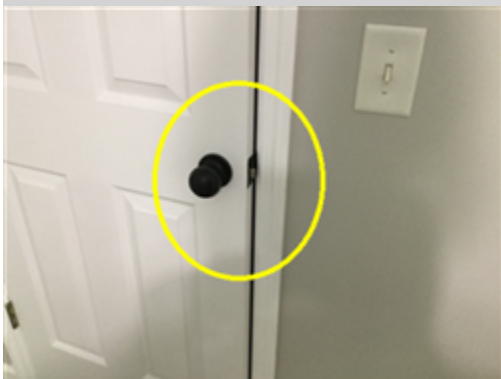
(H3 - 3.1) Front Center Upstairs Bathroom

The door lock assembly in the front right upstairs bathroom is damaged/not functional. The lock could not be engaged to secure the door. The lock needs repair/replacement to ensure that the door closes securely and operates properly. A general repair specialist or licensed general contractor should be consulted for evaluation and repair.

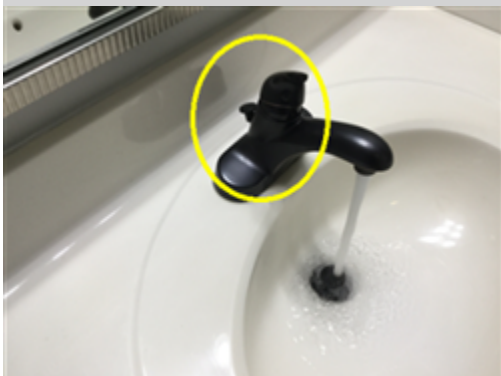
(H3 - 3.2) Front Center Upstairs Bathroom

The sink drain plug in the front center upstairs bathroom did not operate as intended. A licensed plumbing contractor should be consulted for evaluation and repair to ensure proper service.

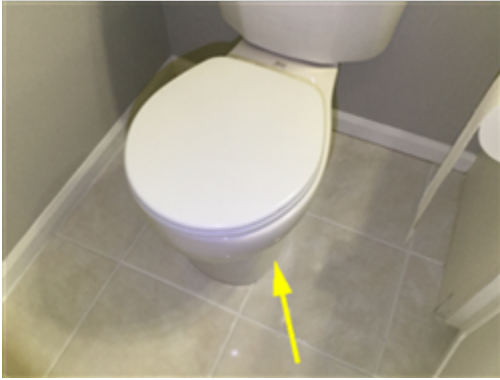
(H3 - 3.3) Front Center Upstairs Bathroom

The toilet in the front center upstairs bathroom rocks and is not secure to the floor. Movement of the toilet can result in leaks and damage. A licensed plumbing and general contractor should be consulted for evaluation and repair.

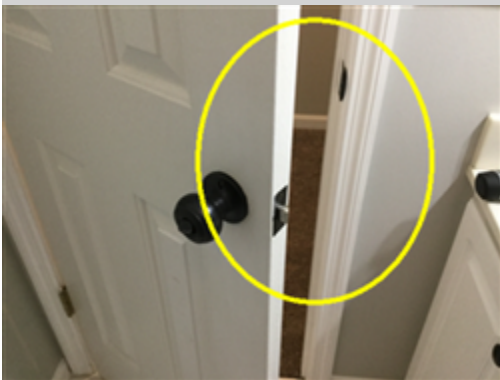
(H3 - 4.1) Upstairs Hallway Bathroom

The door lock assembly in the upstairs hallway bathroom is damaged/not functional. The lock could not be engaged to secure the door. The lock needs repair/replacement to ensure that the door closes securely and operates properly. A general repair specialist or licensed general contractor should be consulted for evaluation and repair.

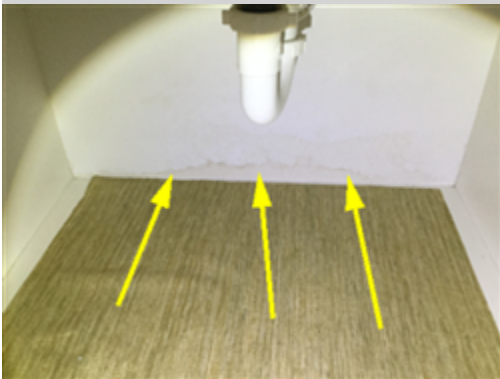
(H3 - 4.2) Upstairs Hallway Bathroom

There is evidence of a leak in the cabinet underneath the sink in the upstairs hallway bathroom. The inspector could not determine whether this was an active or current leak. The owner should be asked for information regarding a leak in this area of the home and if required, a plumbing contractor should be consulted to assess this area of the home and recommend repairs.

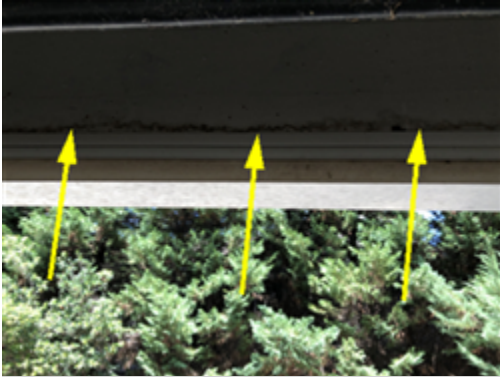
(H4 - 1.1) Garage

Stains above the garage door on the inside indicate that water has entered the garage area adjacent to or around the metal lintel. A licensed general contractor should be consulted to determine the significance of this concern and to make necessary repairs.

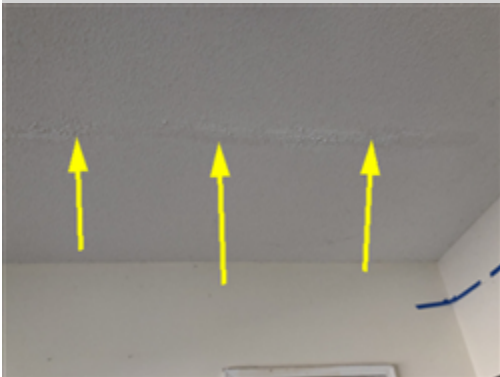
(H4 - 1.2) Garage

There is evidence of damage/repairs on the ceiling of the garage that may indicate a history of a leak. At the time of the inspection it was not possible to determine if the condition was due to an active or past occurrence. Further investigation by a repair specialist and owner disclosure is recommended.

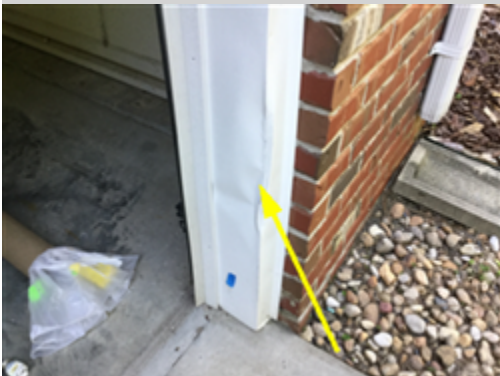
(H4 - 1.3) Garage

The garage door needs adjustment and repair. The right side panel is bent/damaged. A garage door installation company or a licensed general contractor should be consulted for evaluation and repair to ensure that the door operates safely and properly.

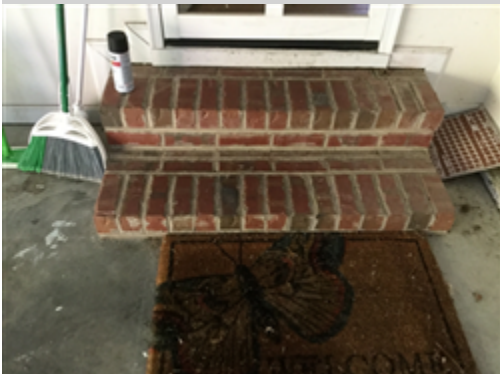
(H4 - 1.4) Garage

The bottom step at the entrance of the home from the garage has a noticeable variance in the height. This configuration could result in the trip or fall hazard as someone enters or leaves the home. A licensed general contractor should be consulted to review the steps and repair as needed to ensure safe access and egress.

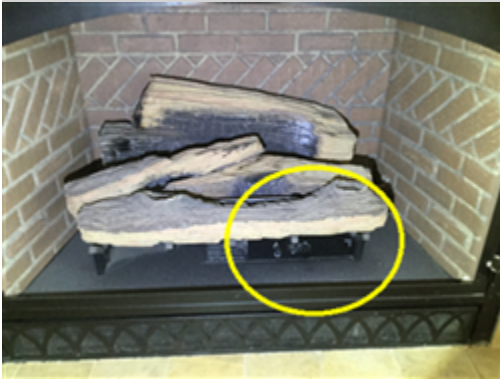
(H6 - 1.1) Fireplace: Pre-Manufactured

The gas log unit was visually inspected but not operated because the pilot was off. The unit should be serviced and operated prior to closing to ensure safe and proper operation of the HVAC system.

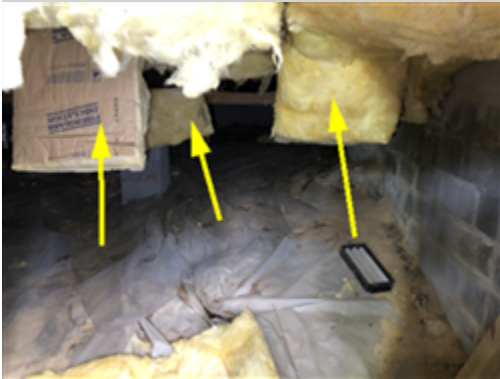
(I1 - 2.1) Crawl Space: All Accessible Areas

The insulation is/has been wet due to leaks or elevated area moisture levels and is missing, hanging or has fallen to the floor of the crawl space. Typically insulation must be replaced if it has been wet because it does not retain fire protective coatings. The insulation needs to be replaced and the adjacent areas inspected for damage. A licensed general contractor should be consulted for repair/replacement.

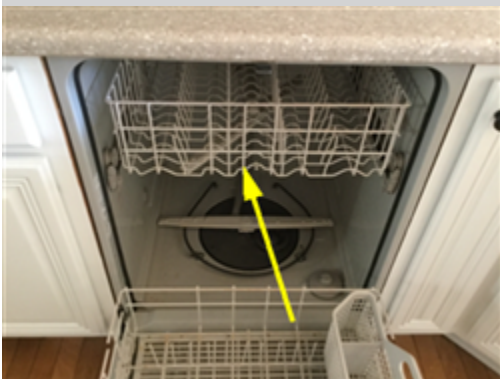
(J1 - 1.1) Dishwasher

The dishwasher was operated through the "Normal Cycle" or until a defect was discovered. The unit was inspected to function and complete the cycle, but the effectiveness of the cleaning was not determined.

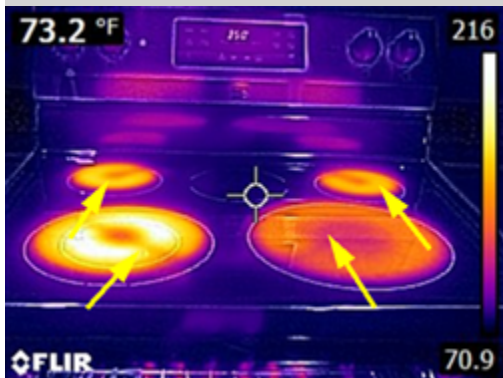
(J1 - 2.1) Range: Electric

The range elements were operated with indicator set to HIGH until the element was noted to be fully red or until a defect was noted. The unit calibration was not verified. If the client would like to verify temperature calibration, an appliance specialist should be consulted.

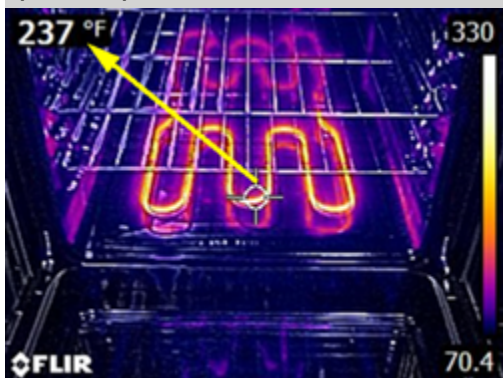
(J1 - 3.1) Oven: Electric

The oven elements were operated with indicator set to HIGH until the element was noted to be fully red or until a defect was noted. The unit calibration was not verified. If the client would like to verify temperature calibration, an appliance specialist should be consulted.

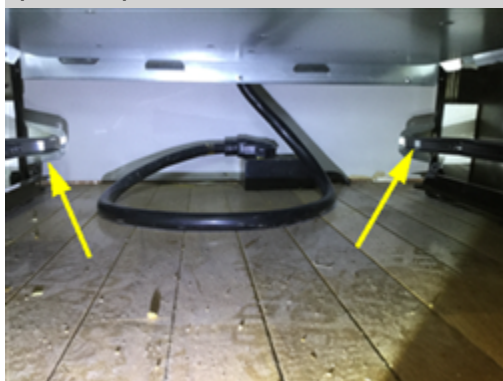
(J1 - 3.2) Oven: Electric

The oven moves forward when the door is opened. The oven needs to be secured or anchored with an anti-tip bracket to prevent the unit from turning over when weight is applied to the door. An appliance repair specialist or general contractor should be consulted for further evaluation and repair.

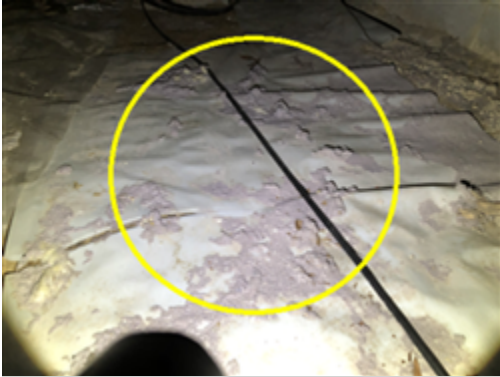
(J1 - 4.1) Vent: Dryer

The dryer duct is has been exiting into the crawl space. The dry exhaust exposes the wood framing and other systems in the foundation area to excessive moisture and lint build-up. Electrical and mechanical systems can pose a fire hazard when exposed to lint. Improper dryer exhaust duct installation can result in condensation and lint build up that will cause the dryer to overheat creating a fire hazard. A licensed general contractor or general repair specialist should be consulted for further evaluation to make sure the duct is properly installed, not clogged, and to make necessary repairs.

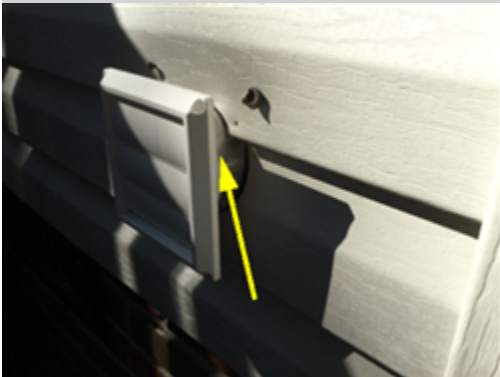
(J1 - 4.2) Vent: Dryer

There is an old dryer duct at the rear of the home near the deck staircase that is not properly secured to the exterior cladding of the home. Upon further investigation the inspector confirmed that this duct has been taped over inside the crawl space and another duct is now running to the left side of the home near the garage door. A licensed general contractor or general repair specialist should be consulted for further evaluation and to make necessary repairs.

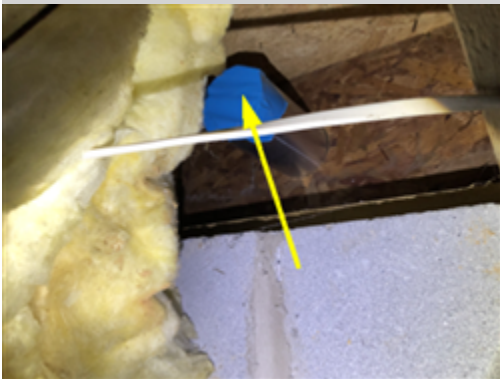
(J1 - 4.3) Vent: Dryer

Image of the dryer duct from inside of the crawl space showing the duct taped shut and no longer in use.

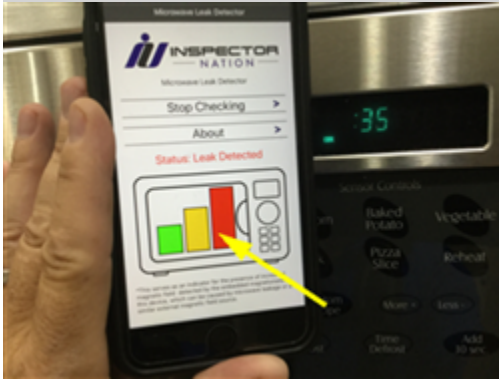
(J1 - 5.1) Microwave: Over Range

The microwave was tested for leakage at the door area during operation. The test indicated leakage above what is considered safe or normal. An appliance repair specialist should be consulted for further evaluation and repair to ensure safe and proper operation of the appliance.

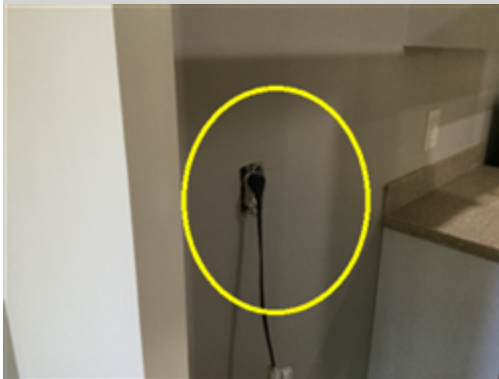
(J1 - 6.1) Refrigerator

The receptacle behind the fridge does not have a protective cover plate. This could result in increased shock and fire hazards. A licensed electrical contractor should be consulted to make necessary repairs to ensure safe and proper operation and installation.
